# Manhole Inspection Summary

Manhole # S13II\_040MH

**Location** Address: **1814 N DUKELAND ST** Cross Street: **W NORTH AVE**

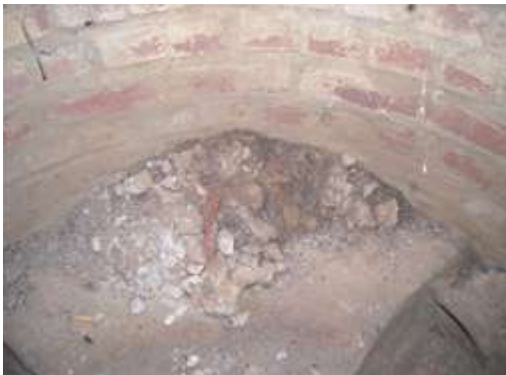
Defect 6

**Bench** ☒ Exists Material: **Brick** ☐ Parged  
Condition: ☐ Sound ☐ Cracked ☐ Root Intrusion ☐ Deteriorated ☐ Leaks ☒ **Debris**

debris on bench

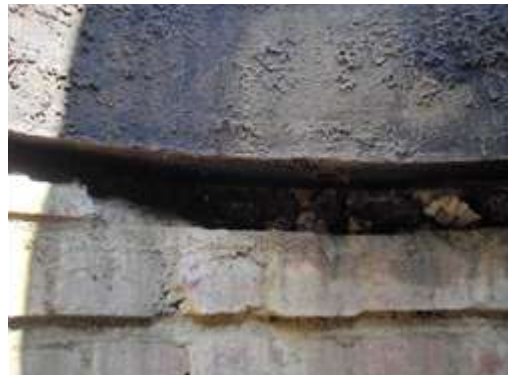
Defect 5

**Frame** Offset: **0** (in.) Condition: ☐ Sound ☒ **Cracked** ☐ Leaks

cracked between frame and corbel

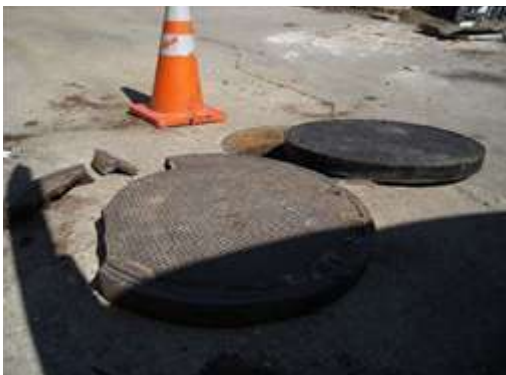
Defect 4

Comments **FOUND CRACKED 30" LID ON 2-21-09. ON 2-23 BROKE AND REPLACED PREVIOUS LID. USED 16LB SLEDGE AND PICKAXE TO PRY OPEN. INSPECTION COMPLETE.**

broken cover

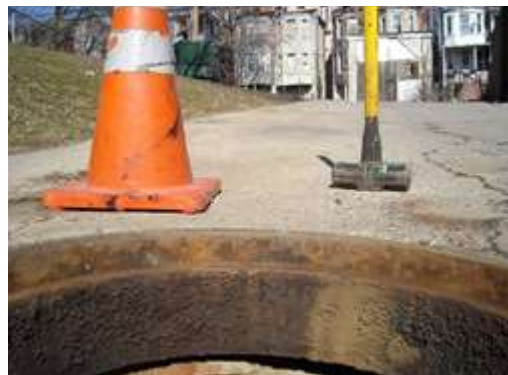
Defect 3

**Manhole** Type: **Junction** Location: **Alley** Ground Conditions: **Dry**  
☐ Prev. Rehab Weather: **Dry** Subject To Ponding: **Sheeting**

sheeting

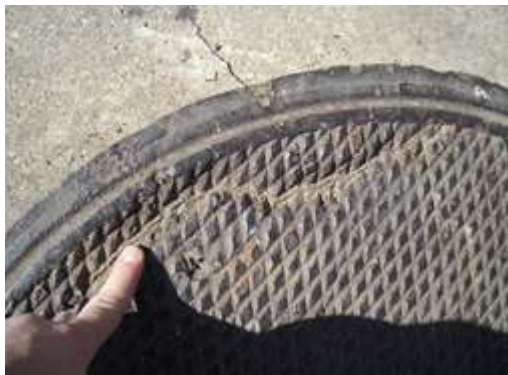
### Defect 2

**Cover** Shape: **Circular** Diameter: **30** (in.) Length: (in.) Dist A/B Grade: **0** (in.)  
Type: **Sanitary** Condition: **Cracked** Cover Material: **Cast Iron**  
Properties: ☐ Bolted ☐ Vented ☐ Water Tight ☐ Water Tight Insert

cracked cover

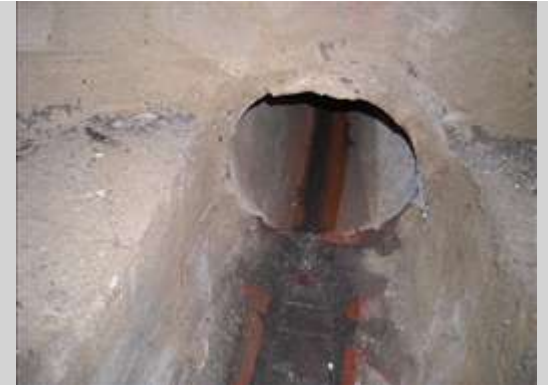
12 O'Clock Outflow

Pipe Height: **8.4** (in.) Rod and Bar (Angled)  
Pipe Material: **Clay** ☐ Pipe Lined  
Invert Depth: **6.95** (ft.) Flow Characteristics: **None**  
Deposits: ☒ None ☐ Mud ☐ Sludge ☐ Debris ☐ Grease  
Silt Depth: (in.) Deposits Extent:  
Infiltration: **None** Pipe Seal Cond: **Sound**

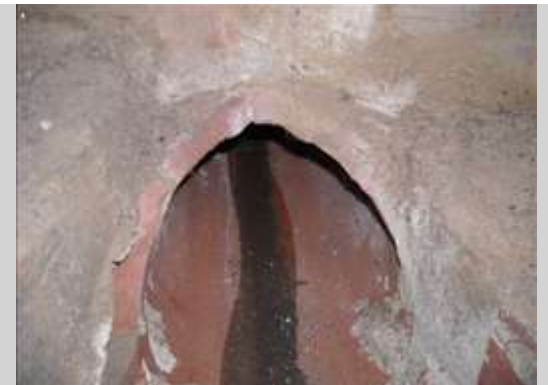
5 O'Clock Inflow

Pipe Height: **6** (in.) Rod and Bar (Angled)  
Pipe Material: **Clay** ☐ Pipe Lined  
Invert Depth: **6.60** (ft.) Flow Characteristics: **None**  
Deposits: ☒ None ☐ Mud ☐ Sludge ☐ Debris ☐ Grease  
Silt Depth: (in.) Deposits Extent:  
Infiltration: **None** Pipe Seal Cond: **Sound**

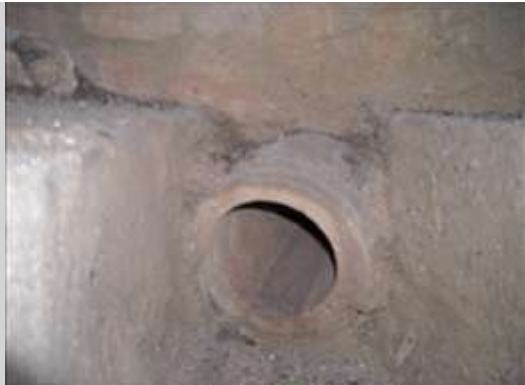
8 O'Clock Inflow

Infiltration: **None**

Pipe Seal Cond: **Sound**
